Certificate

GREEN AUDIT AND QUALITY AUDIT REPORT
OF
NEW HORIZON COLLEGE

MARATHAHALLI, BENGALURU – 560 103
2021 – 2022

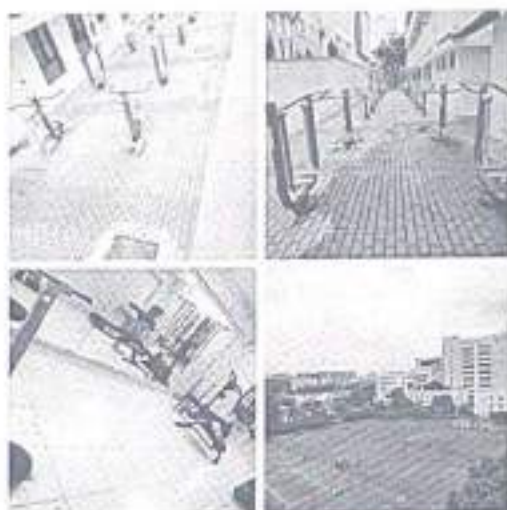
Figure 1-1; Facilities inside the campus for physical wellness

The management has provided physical wellness equipment in the hostel, open (outdoor gym) near NSB block, indoor gym in BSB, Indoor Arena in Sandeep Unnikrishnan Block, playground and basketball court. Pictures of the playground, gym and open space gym are given in figure 1.1.

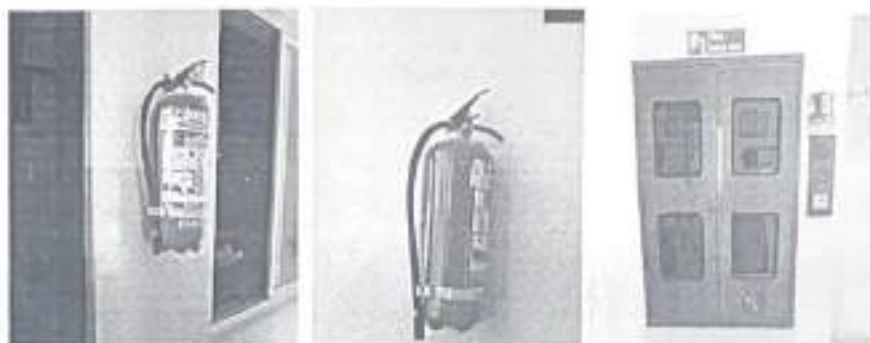
Figure 3-2: Fire Extinguisher and Fire hydrant system

All the students, teaching and non-teaching staff, maintenance and house-keeping staff have been given training to use fire extinguishers in emergency situations of fire and explosion. Fire extinguishing cylinders have been installed in each floor and in laboratory areas. Safety policy statements and use of fire extinguisher has been posted at each block and the same is shown in the figure 3-1. Sample photos of fire extinguishers and fire hydrant system are as shown in figure 3-2.

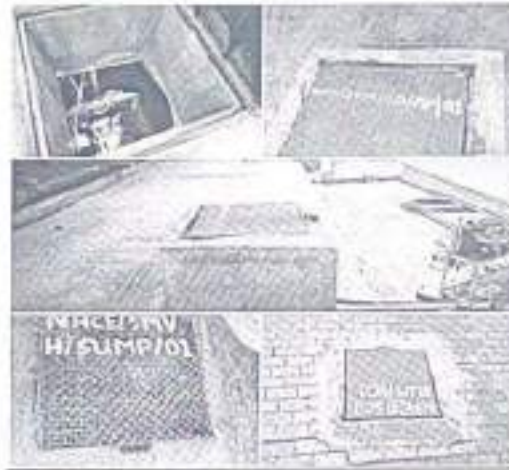
Figure 4-2: Sumps in the campus

- From the sump tank, the water is pumped to the overhead tanks located in the terrace by submersible pumps. The pictures of UG Sumps and Overhead tanks are given in figure 4.2 and figure 4.3.

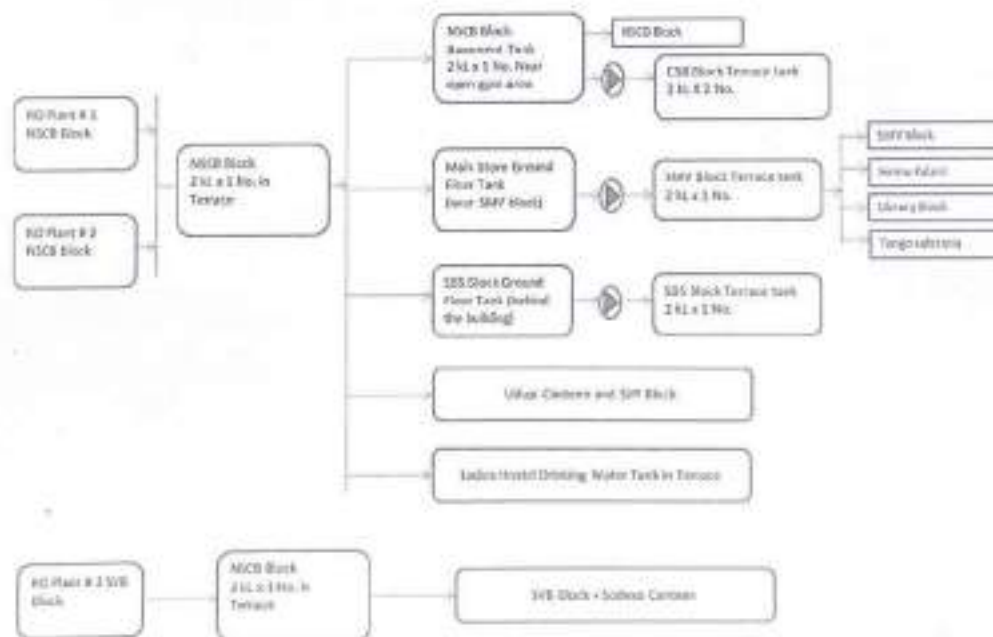
Figure 4-4: Schematic of drinking water system in the campus

The drinking water requirement of the entire campus is met by RO water system installed the campus. Three numbers of RO plant is available in the campus. Two numbers of RO plants are installed in NSCB block and one number of RO plant is installed in SVB block. The schematic of drinking water system is given in figure 4.4.

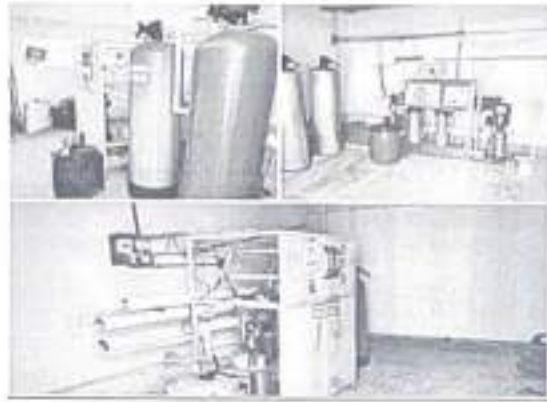
Figure 4-5: RO water treatment plant in the campus

- One number of 2000 litres capacity drinking water tank is available in ground floor of SBS block (behind the building). The input supply to this tank is from the main drinking water distribution header. From the ground floor drinking water tank, water is pumped to SBS block terrace drinking water tank – 2000 litres capacity, one number. From this tank, the water is supplied to the SBS block. The picture of RO plant installed in the campus is given in figure 4.5.

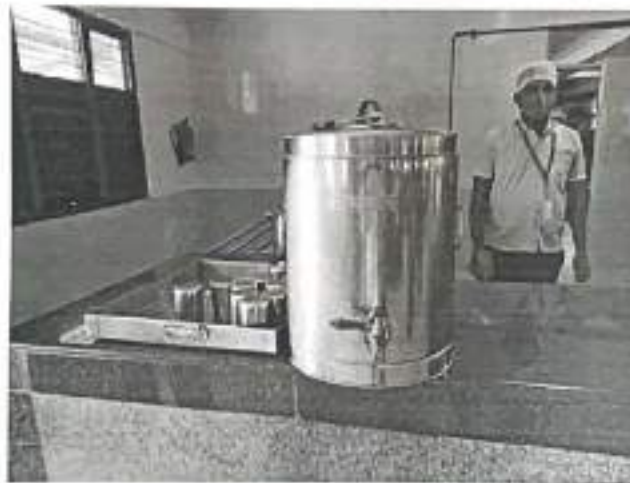
Figure 4-9: Hot water supplied in canteen

The hot water supplied in canteen for drinking purposes is shown in figure 4.9.

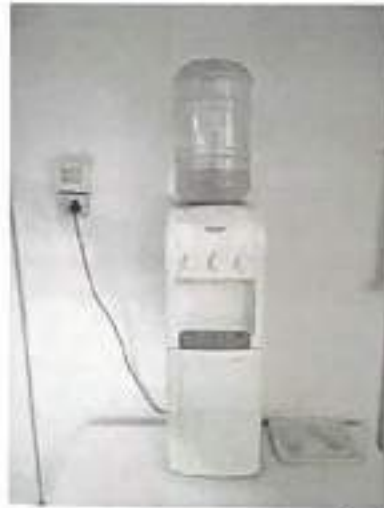
Figure 4-10: Hot water dispenser available in college

The hot water dispenser available in college for drinking purposes is shown in figure 4.10.

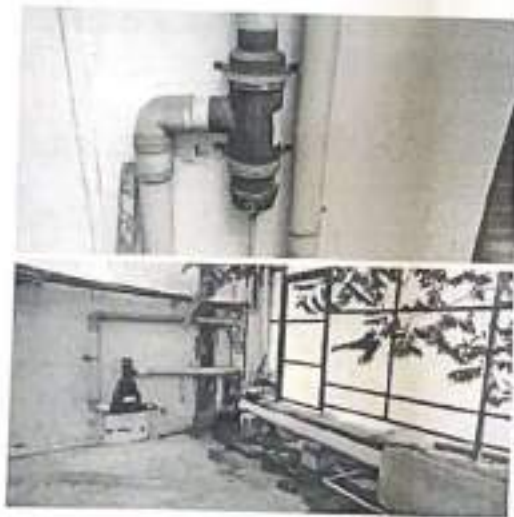
Figure 4-11: Rain water harvesting system in the campus

- Figure 4-11 depicts the sample rain water filters installed in each blocks.

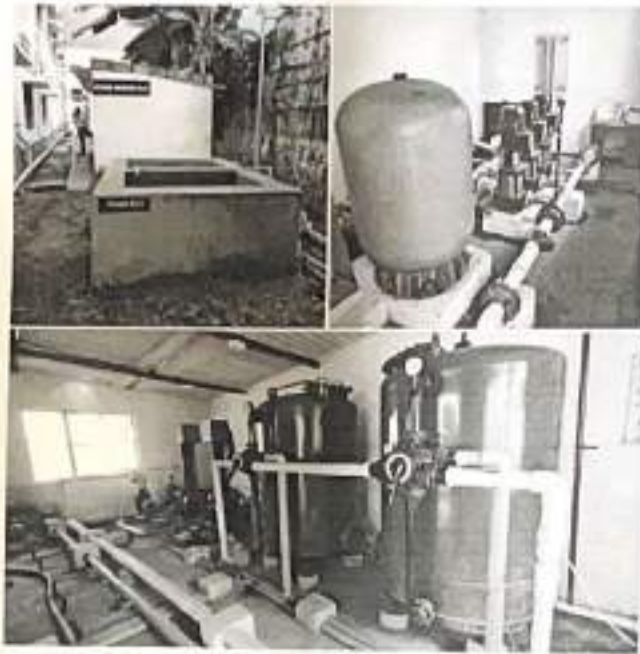
Figure 4-12: Sewage Treatment Plant

- The sources of waste water in the college campus of all blocks are as follows
 - Washrooms
 - Toilets
 - Kitchen
 - Hostel
 - Labs
 - Canteen
- Waste water from the above mentioned sources are collected and treated at sewage treatment plant (STP). The capacity of STP is 200 kLPD (kilo Litres Per Day)
- The plumbing system (waste water collection, waste water transfer to STP, STP treated water storage and STP treated water to land scaping) is very well designed, the pipes are laid underground, and access / chambers are provided to regulate and control the flow of water.
- The treated water from the STP is distributed via underground pipes to the entire campus for flushing, Cleaning and gardening purposes.
- All the blocks have dual water piping system to use STP treated final water for flushing purposes
- The picture of STP facility is show in figure 4.12.

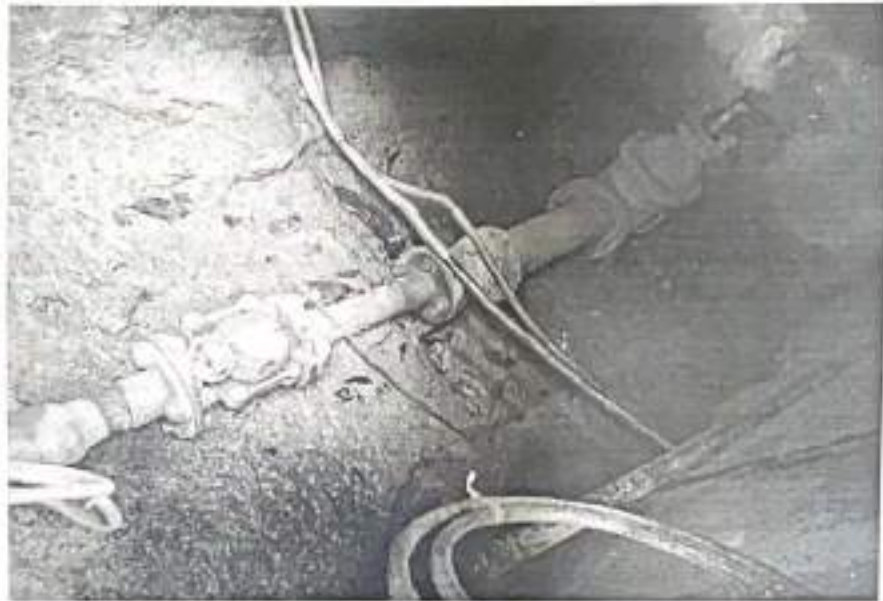
Figure 4-15: Water flow meter installed in the campus

One number of water flow meter is installed near gate# 3 to quantify the water used. Regular monitoring of water consumption data and recording of data is being carried out. The water flow meter is shown in figure 4-15.

- Installation of water flow meters for individual blocks and monitoring the block wise water consumption
- Regular checking of taps and valves to avoid leaks and water wastage
- Conduct seminars, workshops and exhibitions on water conservation

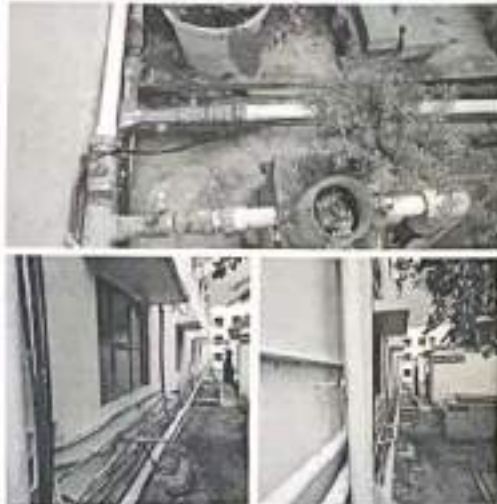
Figure 4-16: Dual water piping system installed in the campus

This method of processing the sewage water to convert as treated water, and utilizing in all possible areas would have resulted in substantial amount of water savings.

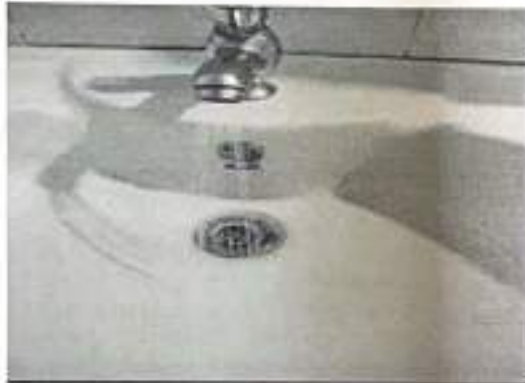
Figure 4-17: Low flow taps installed in the college

- Saves water
- Reduced water bill
- Optimized flow rate
- Different flow patterns (shower/Foam)
- Annual Savings upto 10,000 litres/Year/tap

The picture of low flow taps used in the college is shown in figure 4.17.

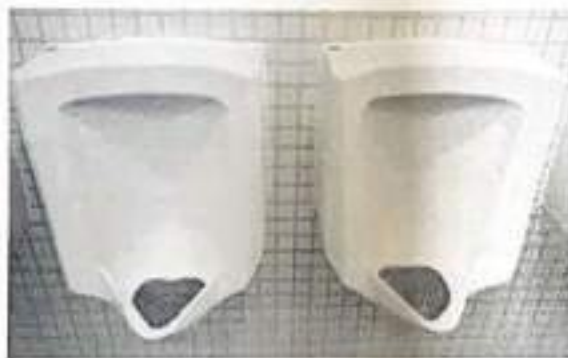
Figure 4-18: Water less urinals installed in the college

- Saves water
- Reduces water bill
- Reduces maintenance cost
- Reduces water handling cost (electricity cost for pumping raw water)
- Reduces usage of chemicals
- Improves overall bathroom hygiene

The poster of water less urinals is shown in figure 4.18.

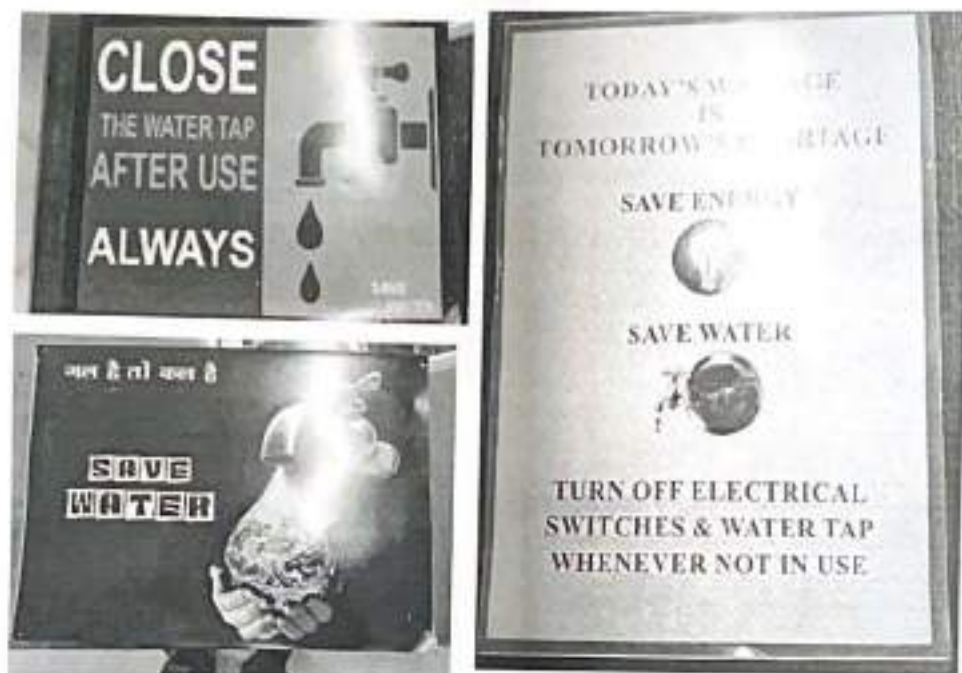
Figure 4-22: Posters to conserve water

- Regular checking and maintenance of pipelines are done to control water wastage.
- Water conservation awareness campaigns are organized, dedicated staff members have been deputed for this activity and support of trust members is also extended.
- Usage of sign boards in all the wash rooms are posted to create awareness for water conservation, sample photos are taken during the audit and are shown in figure 4-22.

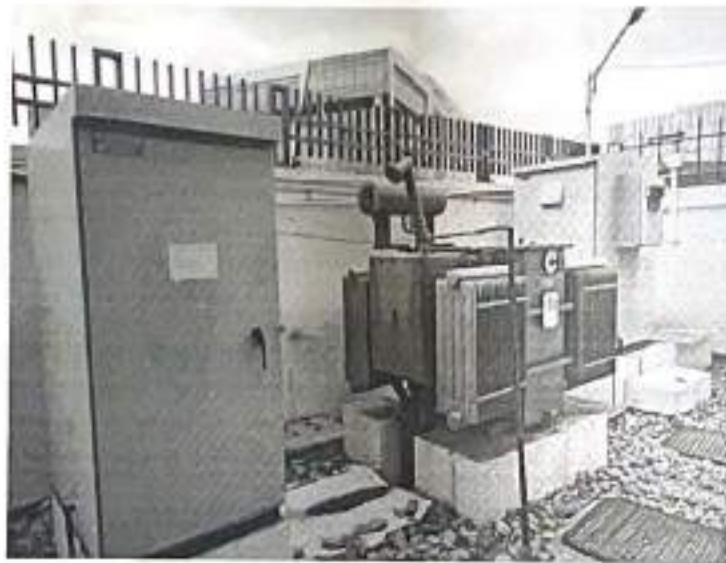
Figure 5-1: Transformer unit Installed in the campus

Incoming power supply from BESCOM is received at the transformer yard inside the college premises. The 11 kV rated HT power supply is stepped down to LT 433V, by one number of 500 kVA rated transformer. Transformer unit installed inside college premises is as shown in the figure 5-1.

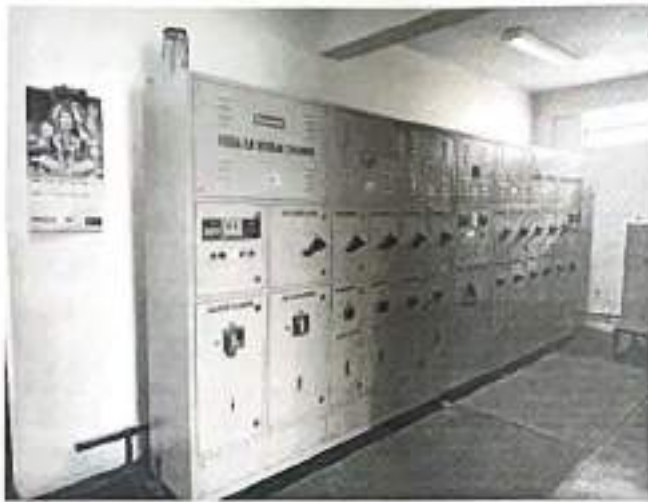
Figure 5-2: Electrical panel Room

The LT supply from the transformer is taken to the main distribution panel located inside the Electrical panel room near the transformer yard. Electrical panel room is as shown in the figure 5-2. One number of 400 kVAr rated capacitor bank have been installed at the main incomer panel for power factor improvement.

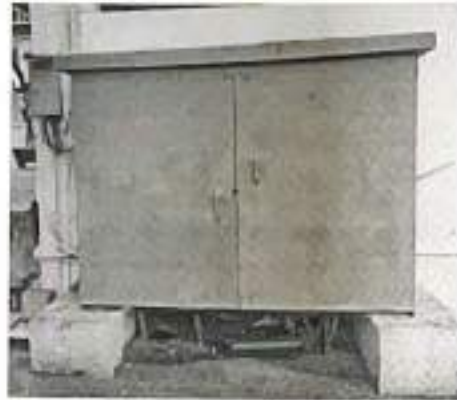
Figure 5-4: Feeder Pillar near NSB block

Power supply cables from the electrical panel room is distributed to the various distribution panels placed inside the blocks. From the main LT sub-station panel room, power supply is catered to individual blocks. There is an feeder pillar installed near the NSB block. From this feeder pillar the power is supplied to SVP block, NSB block, RC block and JKR block. For all the other remaining blocks, the power is supplied directly from the LT sub-station panel room. Figure 5.4 shows the feeder pillar near the NSB block. The electrical panels located in various blocks sample pictures are given in figure 5.5.

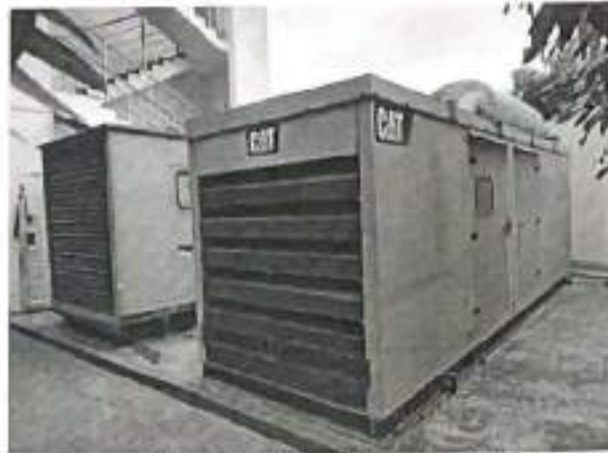
Figure 5-6: Diesel Generator (DG) sets

Two numbers of DG (Diesel Generator) sets are used for backup power supply, during power failure from BESCOM. DG set installed at the college premises is shown in the figure 5-6. The name plate specification rating of the DG set is shown in the table 5-2.

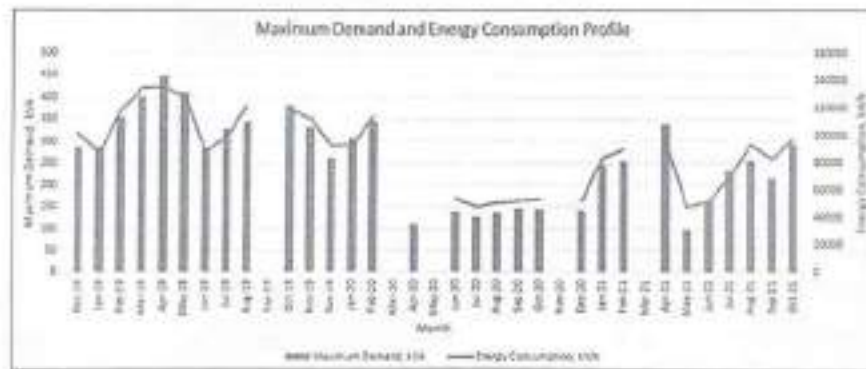
Figure 5-7: Month wise Recorded Maximum Demand and Energy Consumption

Figure 5-7 indicates the month wise recorded maximum demand and month wise energy consumption of the college campus for the last three years (Dec 2018 to Oct 2021).

From the maximum demand curve, it was observed that maximum demand registered during the month of March 2020 was found to be 446 kVA and is the peak demand during the last three years of billing period. Average of registered maximum demand during December 2018 to October 2021 is 349.33 kVA.

From the month wise energy consumption profile, it was observed maximum energy consumption was registered during April 2019. Average monthly energy consumption is 10,66,751 kWh.

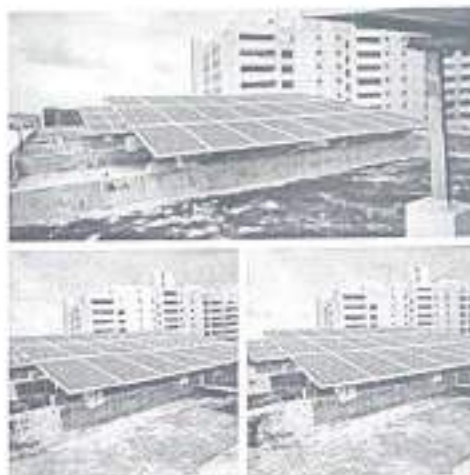
Figure 5-8: Solar rooftop PV system installed in SVP block

The SRTPV is off-grid system type with battery backup. During the audit, photo of SRTPV systems are collected and is shown in figure 5-8 and figure 5-9.

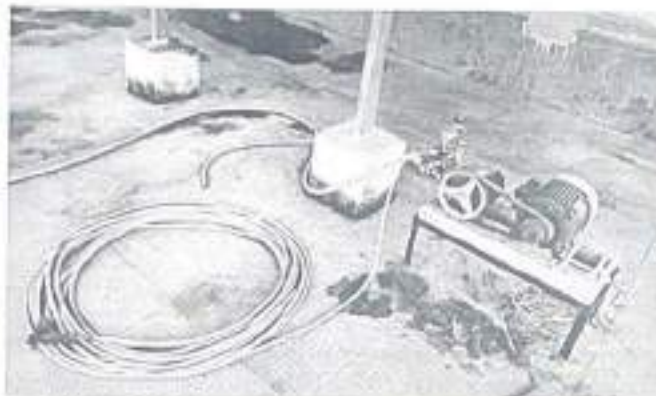
Figure 5-10 Pressurized water cleaning for SRTPV systems

The SRTPV system panels are well maintained and cleaned on regular basis. To remove the dust accumulated on the solar panel cells, pressurized water system is used for cleaning. The picture of the pressurized water cleaning system is given in figure 5.10.

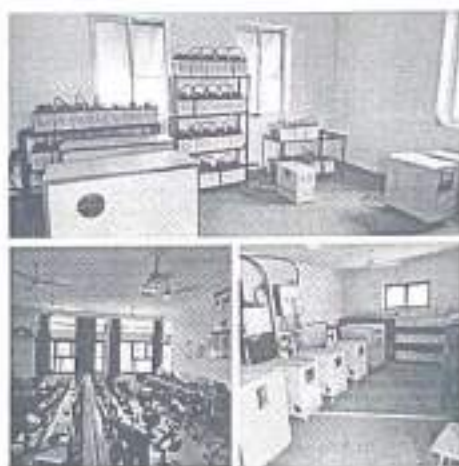
Figure 5-11: Well-ventilated and day-light integrated rooms

During the audit phase classrooms, Staff-rooms, computer lab, seminar hall, UPS & batteries room and library areas were surveyed for illumination levels and fresh air-circulation. It was observed most of the rooms are well ventilated and day-light integrated; sample photos are shown in figure 5-11 and figure 5-12.

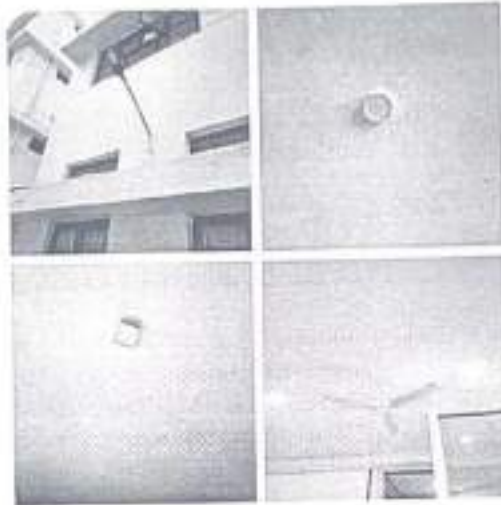
Figure 5-13: Use of LED lights

Many of the FTL in all the blocks of the campus are replaced with LED lights. LED tube lights are used in the class rooms, staff-rooms, corridors, hostel, dining area, building façade lighting and in the library area. Sample photo of LED lamp used in the some of the location of the college area are shown in figure 5-13.

- Conduct training and awareness programs on energy conservation
- Demand optimization
- Replacement of conventional FTL lamps with energy efficient LED lamps in phased manner, as part of procurement practice
- Replacement of conventional fans with energy efficient fans in phased manner, as part of procurement practice,
- Installation of SRTPV (Solar Roof Top Photo Voltaic) system

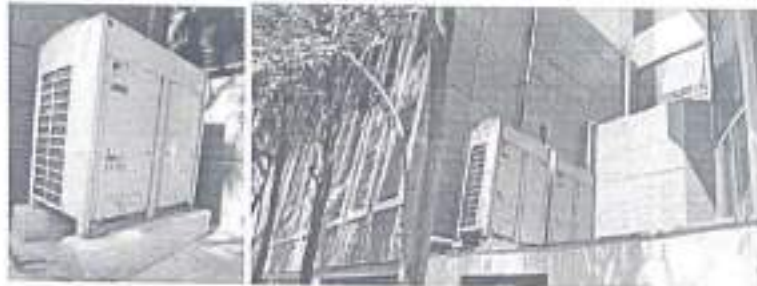
Figure 5-14: VRV Air Conditioning Unit

The conventional air cooled AC units are replaced with energy efficient VRV and Inverter type AC units. Purchase bills of energy efficient AC units are reviewed during the study and sample bill copy is given in figure 5-14 and figure 5-15.

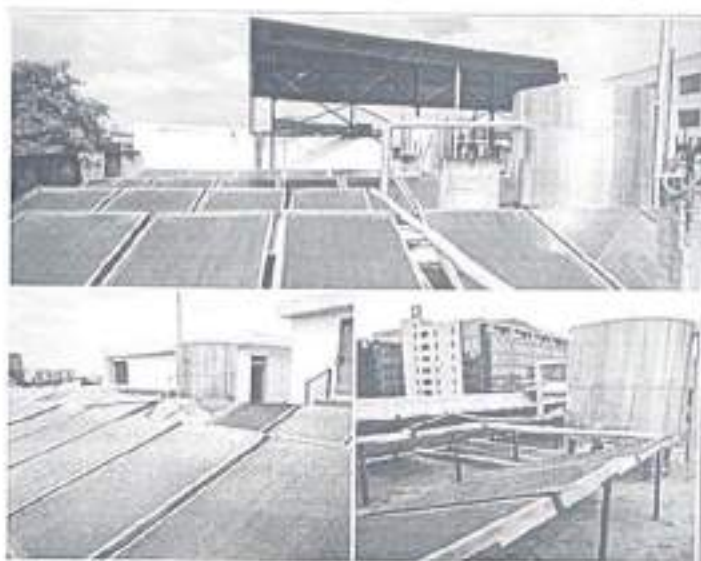
Figure 5-16: Use of Solar Water Heater

Solar water heaters are installed in boys and girls hostel for generating hot water. Sample photo of solar water heater used in the college area are shown in figure 5-16.

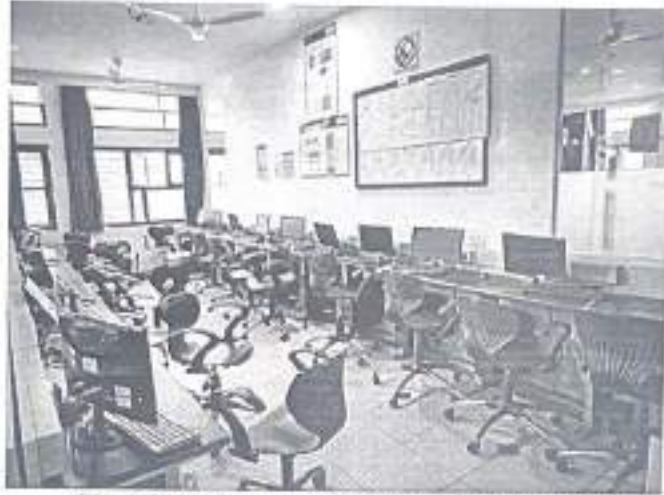
Figure 5-17: Use of LED monitors in the computer labs

LED/LCD monitors are used for all the desktop computers in staff rooms and in computer labs. Sample photos of the computer labs are as shown in the figure 5-17.

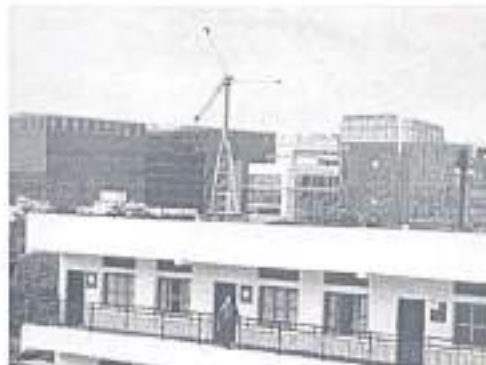
Figure 5-18: Micro wind mill installed in SVP block

Micro wind mill was installed in the terrace of SVP block which is of 1 kW. The power generated from this wind mill is used for illuminating the lights in the class rooms and two number of street lights during night time. Figure 5-18 shows the picture of wind mill installed in SVP block. Purchase order of the wind mill is as shown in the figure 5-19.

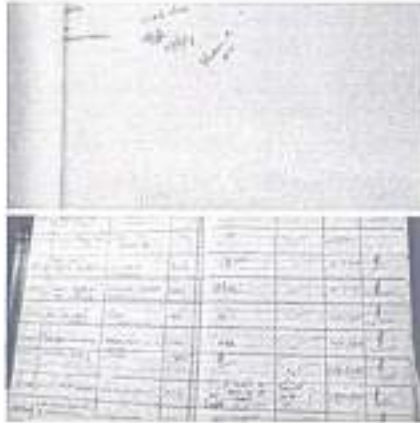
Figure 5-21: Complaints and Maintenance Register

There is a systematic process in place for complaints and maintenance monitoring. The complaints are sent by email and recorded manually in the log register. Once the complaint is attended and fixed, manual sign of completion is obtained from the person raised the complaint and then the complaint gets closed in the register. The pictures of the complaint and maintenance register are shown in figure 5.21.

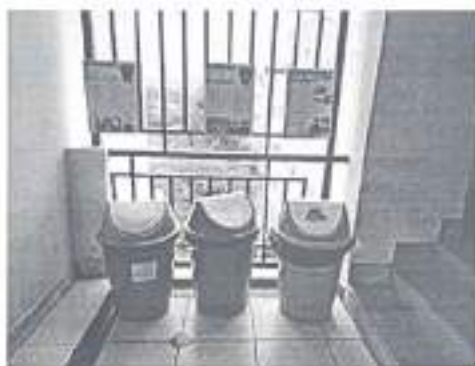
Figure 6-7: Dry and wet waste collection bins at different places

The garbage segregation is done and the garbage is given to external agencies / municipal agencies from time to time in order to maintain the college premises clean & hygiene. Figure 6-7 shows the waste segregation bins at each floor in the college campus.

Waste collection bins of different colors Blue, Green and Red are kept in all the floors in each block. The self-explanation poster helps the students/ staffs to dispose the waste according to the category in the relevant waste collection bins. The waste collection bins picture is shown in figure 6.7 and the self-explanation poster is shown in figure 6.8 respectively.

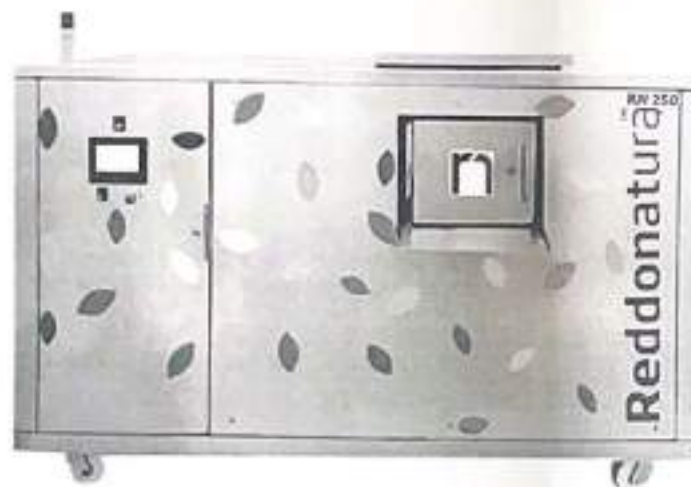
Figure 6-9: Organic Waste Composting Machine

Food waste management through organic waste composting machine. Any type of food or organic waste which is biodegradable can be converted into soil amendment products like compost. Food waste which has to be disposed of gets treated in the organic waste composting machine which is available at campus. . Figure 6-9 depicts the organic waste composting machine in the campus.

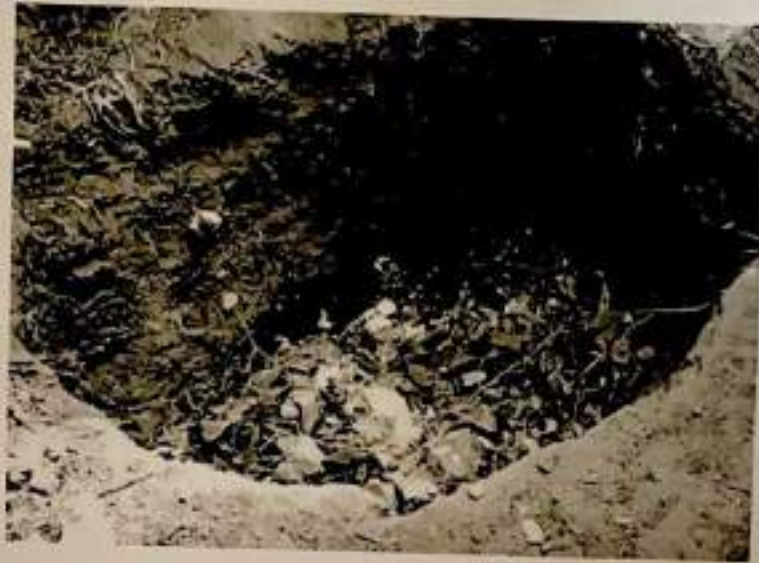
Figure 6-11: Leaf composter available in campus

The dry leaves are collected manually and disposed in the leaf composter. The leaf composter available in the campus is shown in figure 6-11.

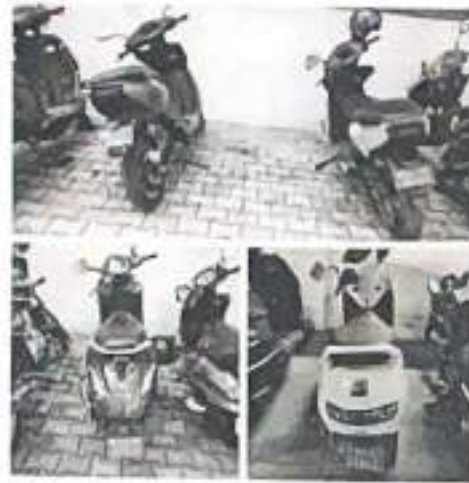
Figure 8-2: Students using Electric Bikes

Some of the students coming to college are Electric bikes. During audit pictures of electric bikes are taken and the same is given in figure 8-2.

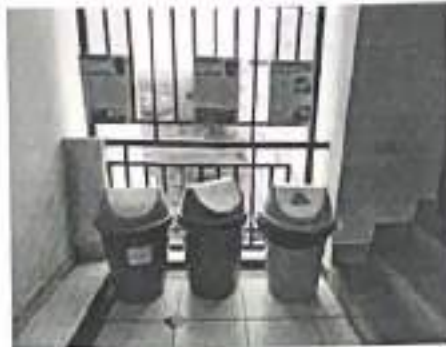
Figure 8-3: Waste Collection Bins

Waste collection bins of different colors Blue, Green and Red are kept in all the floors in each block. The self-explanation poster helps the students/ staffs to dispose the waste according to the category in the relevant waste collection bins. The waste collection bins picture is shown in figure 8.3 and the self-explanation poster is show in figure 8.4 respectively.
